**City of St. Helena  
Library Board of Trustees  
Regular Meeting  
St. Helena Library, 1492 Library Lane, St.  
Helena CA 94574  
St. Helena Library - 1492 Library Lane  
Wednesday, March 14, 2018 @ 5:00 PM**

- 6.4. Review of Draft Library Budget for Fiscal Year 2018/2019 - Chris Kreiden 15 - 22  
[Draft Fiscal Year 2019 Library Budget](#)
- 6.5. Review of Information about Library from EMG's Draft Facility Condition Assessment Report - Chris Kreiden 23 - 74  
Please note: All 856 pages of the report are available online on the web-page for the St. Helena Assets Planning Engagement (SHAPE) Committee (<http://cityofstheleena.org/bc-shape>).  
[Draft EMG Report Library Information](#)

## ASSESSMENT SUMMARY REPORT

## FACILITY CONDITION ASSESSMENT

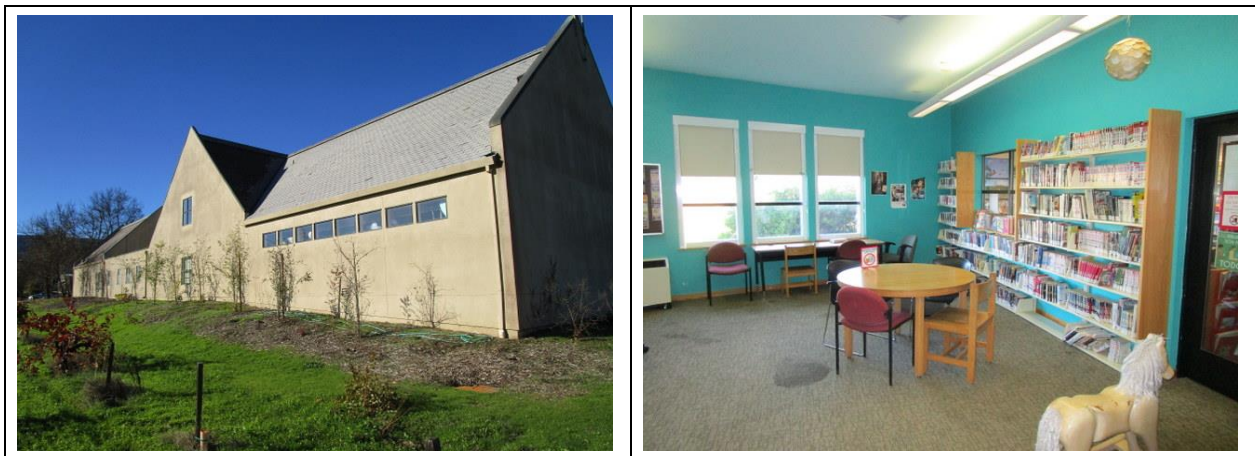
Items requiring immediate attention include the separation of the exterior walls and the heavy timber structural frame posts. Separation between the walls and the timber frame were observed in several places in the reading room and the museum. This structural issue requires review by an engineer to determine action to be taken. Problems were also reported with the effectiveness of the HVAC systems, even with some of the equipment having been recently replaced. EMG recommends recommissioning the systems to ensure they are operating properly and effectively. Other immediate action items include parking lot refinishing, roof repair of an ongoing leak, and replacement of damaged ceiling tiles. The Facility Condition Index of the building is 5.5%, which is equivalent to fair condition but does not take into account that the structural repair cost for the exterior walls.

| Current Year Repairs<br>St. Helena Library | | | | | | |
|---|---|---|---|---|---|---|
| West and east walls where separating | Structural Flooring/Decking, Pressure Treated Timber, Repair | 1 | SF | \$42,600.00 | \$42,600 | \$51,546 |
